07-01-2010 Canada - Michael Potvin RCMP LEO – Boat Accident

Documents offer details on Yukon Mountie's death

No life jackets, a one-of-a-kind boat and too much water contributed to Const. Potvin's death

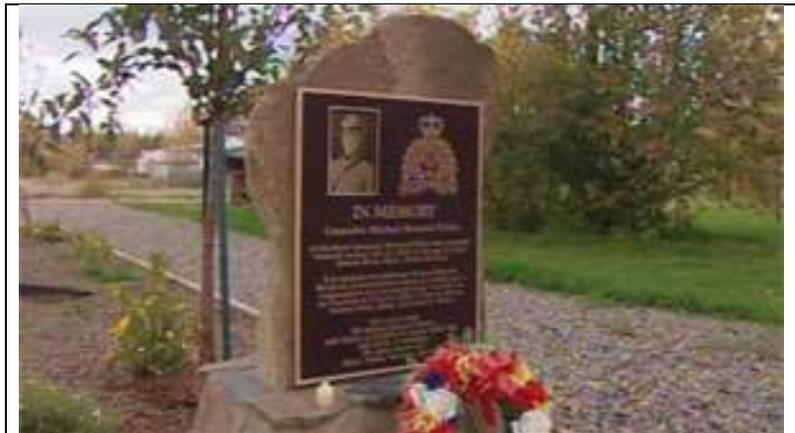
New documents offer details on why RCMP Const. Michael Potvin's boat capsized near Mayo, Yukon. (CBC)
